Can-America PHMGH Inc. 2021 Environmentally Responsible Manufacturer 204-1345 Pembina Highway, Winnipeg, MB R3T 2B6

May 27, 2024

We, Grand Chief Glenn Hudson, and I met at around 11:00 AM at the first white house at the entrance of the Peguis Community.

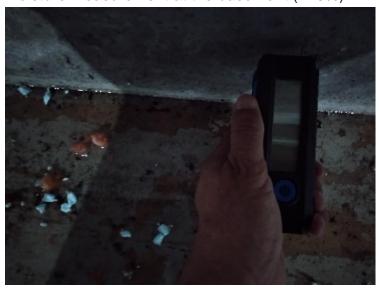
Moisture measurement at the basement.(>40%)

2 pails of water were collected.

- 1. To fix seepage from outside the west wall. Seal or French drainage is suggested.
- 2. There is a leakage from the pipe going out in the west wall that needs to be fixed.
- 3. Must be kept dry the floor on the west wall, all the time.
- 4. Replace the damaged insulation on the east wall, damaged by mice.
- 5. The HVAC is in excellent new condition.
- 6. The supporting west pole is rusted. To be aware of.
- 7. Some woods show mold infection.
- 8. I will ask Dr, Oule to analyze the samples taken.
- 9. Survey mold smell by Thursday, May 30^{th,} and record smell appreciation (1 to 10).
- 10. Next full application by Saturday, June 1st.
- 11. Survey and record smell appreciation by June 8th (scale 1 to 10).
- 12.3rd application by Saturday, June 8th.

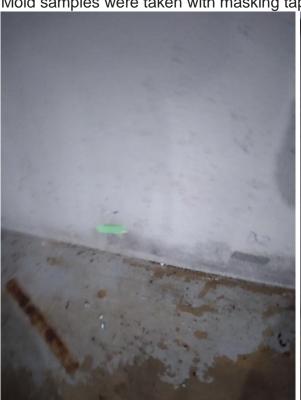
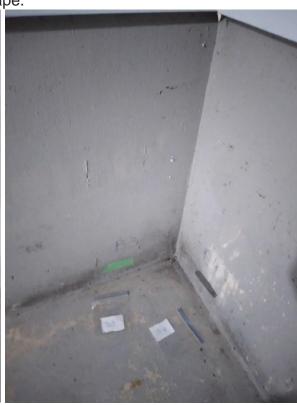
Mold samples were taken with masking tape.

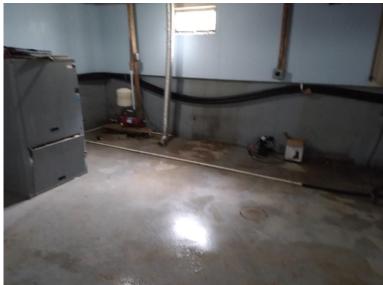
6 bottles (24 liters) were sprayed in the full basement.

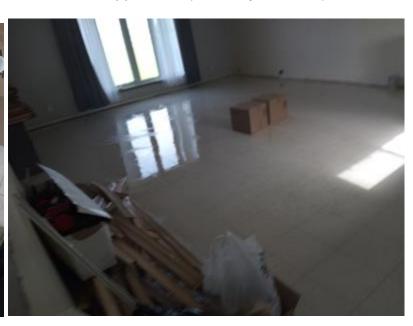
The floor was swept. Left 2 boxes (8 bottles) to be used on the next application (Saturday June 1st).

4 liters to seep the floor.
