### **Summary Report on Stamp Out treatment Peguis Home.**

On May 27, 2024, we met Glenn Hudson at the first white house at the entrance of the Peguis Community to undertake a mold remediation with our product, Stamp Out.

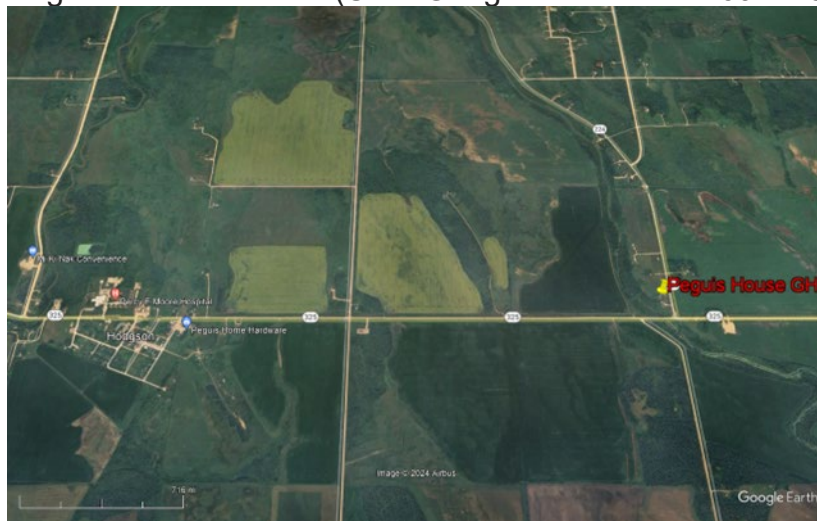
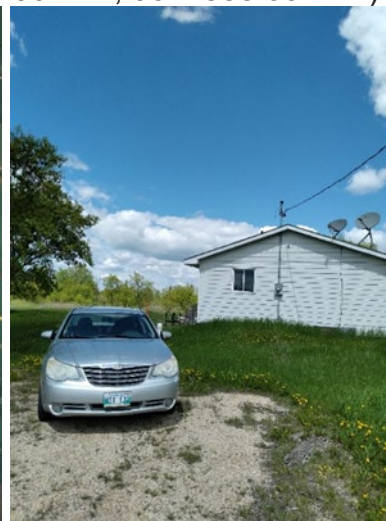
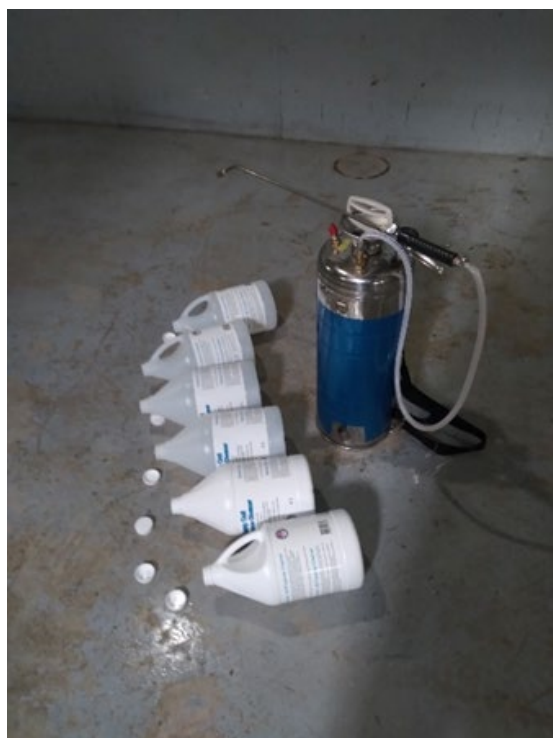
We inspected the house. A mold smell was appreciated. A visual inspection detected some black mold spots on the first floor and a lot of spots in the basement. The mold smell was stronger in the basement.

We performed 3 applications in the whole house, the first floor and the basement. First one on May 27<sup>th</sup>, the second on Jun 1<sup>st</sup>, and the third on Jun 11<sup>th</sup>.

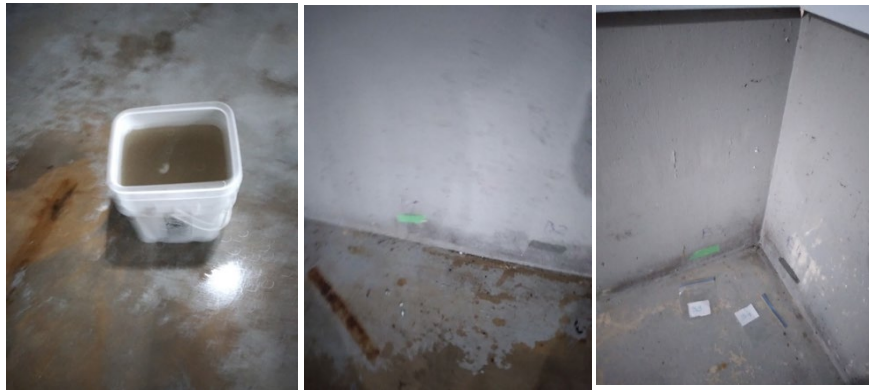
In the first visit, at the West wall of the basement, was flooded. It was collected 2 pails.

1. The seepage on the west wall is still on at the 3<sup>rd</sup> visit.
2. The floor must be kept dry on the west wall, all the time.
3. The smell has decreased considerably. In scale 1 to 10, Basement 3, First floor 1.
4. It is suggested 2 applications/house, in 2 weeks' time frame, summer preferably.

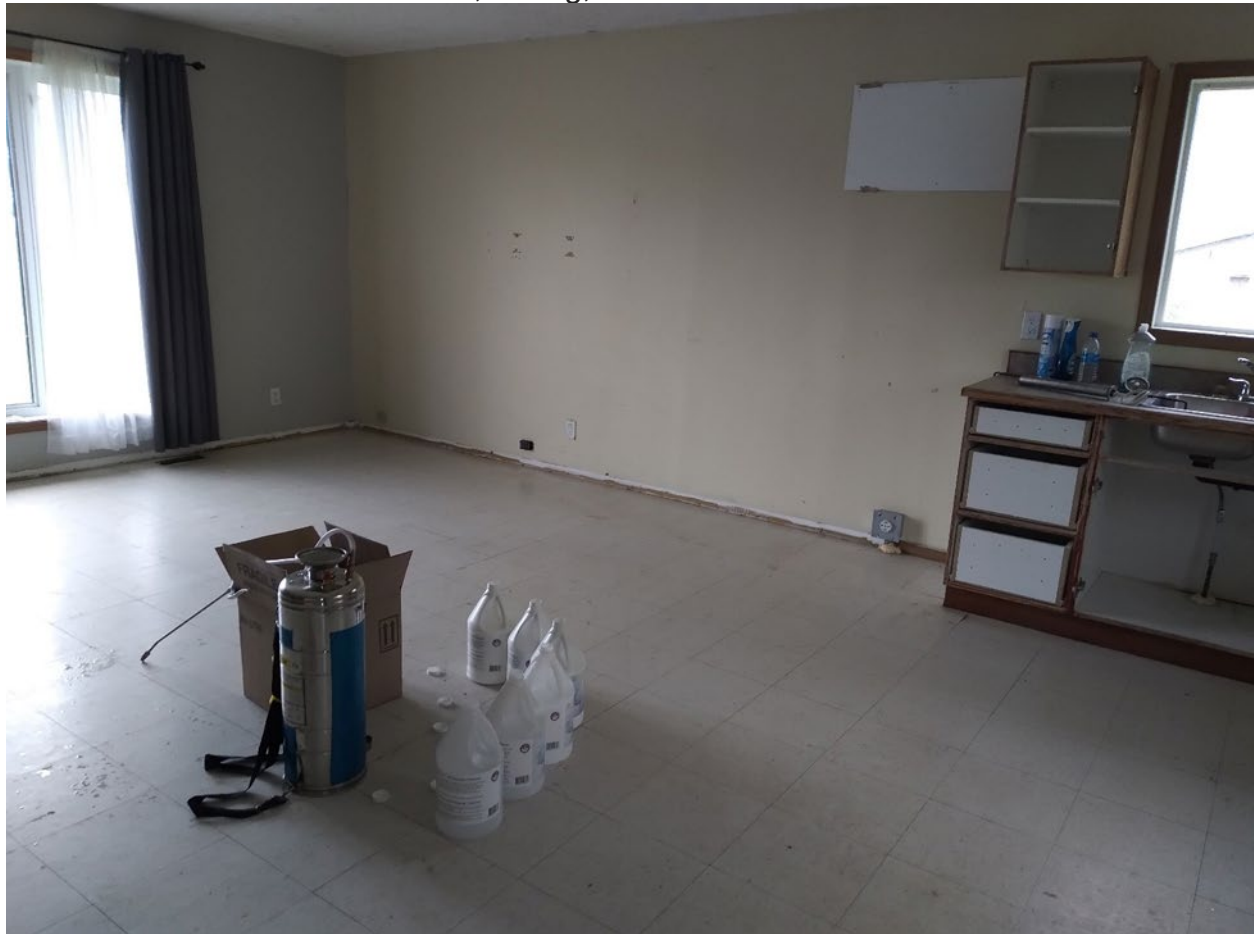
The smell decreased considerably with the 2<sup>nd</sup> application. This is the good indicator that the mold starts to disappear.
